Hydrology and Groundwater Assessment

Melbourne Airport Jet Pipeline Project

Viva Energy Australia

Reference: 521511

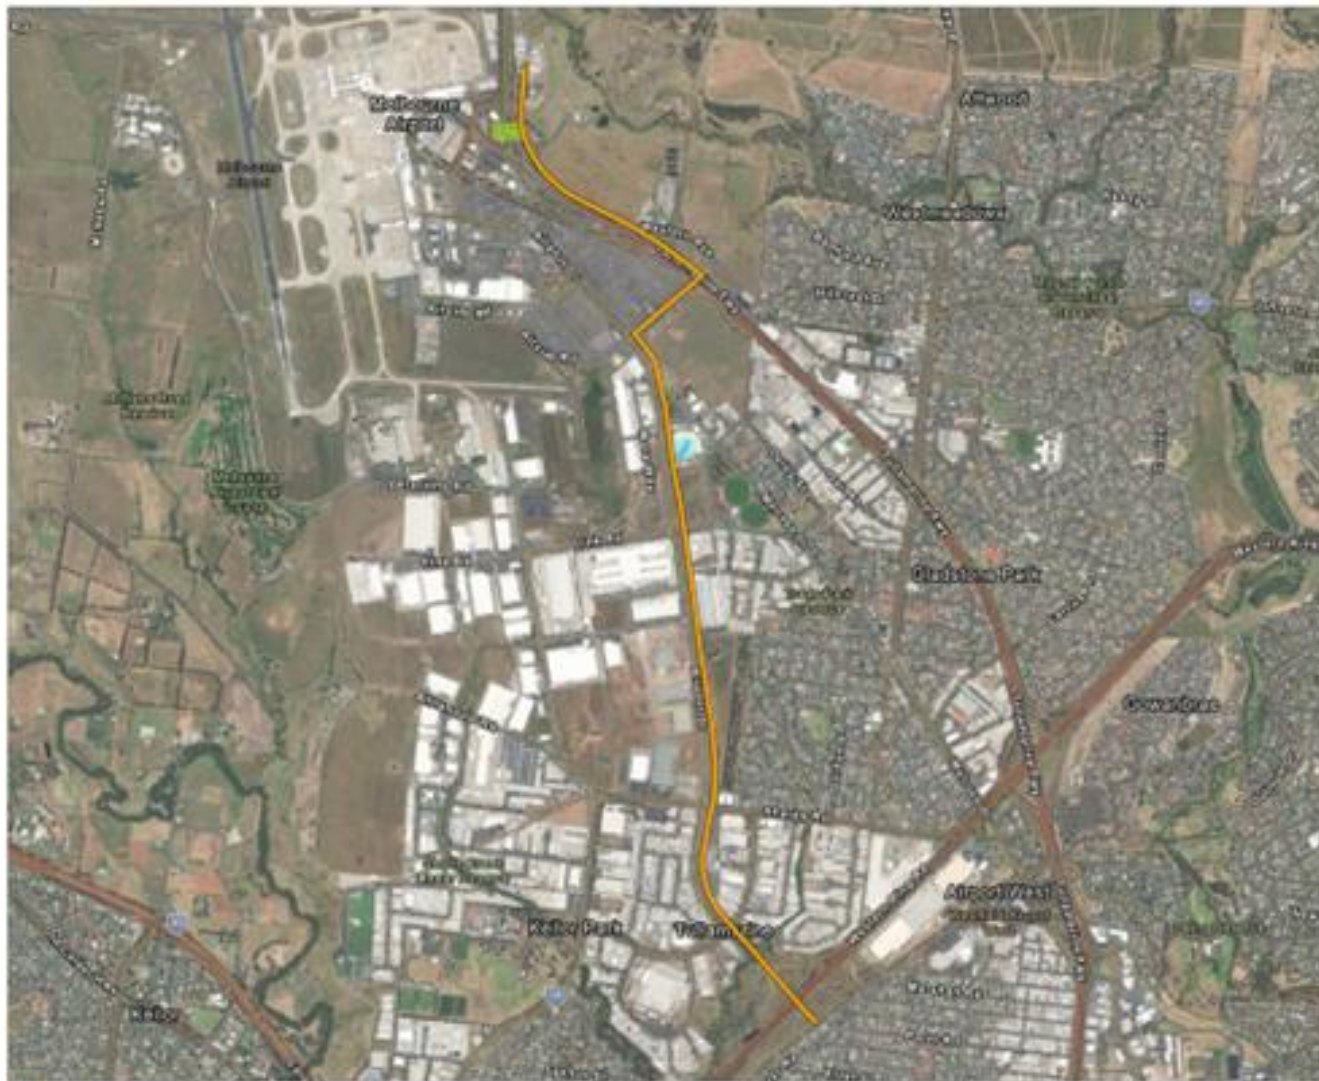
Figure 1-1 Proposed pipeline location

The project would commence at a section of the Altona to Somerton pipeline located south of the Western Ring Road (M80) (near the Airport Drive exit) and link into the existing Melbourne Airport joint user hydrant installation (JUHI) facility (located at Marker Road, Tullamarine) (**Figure 1-1**).

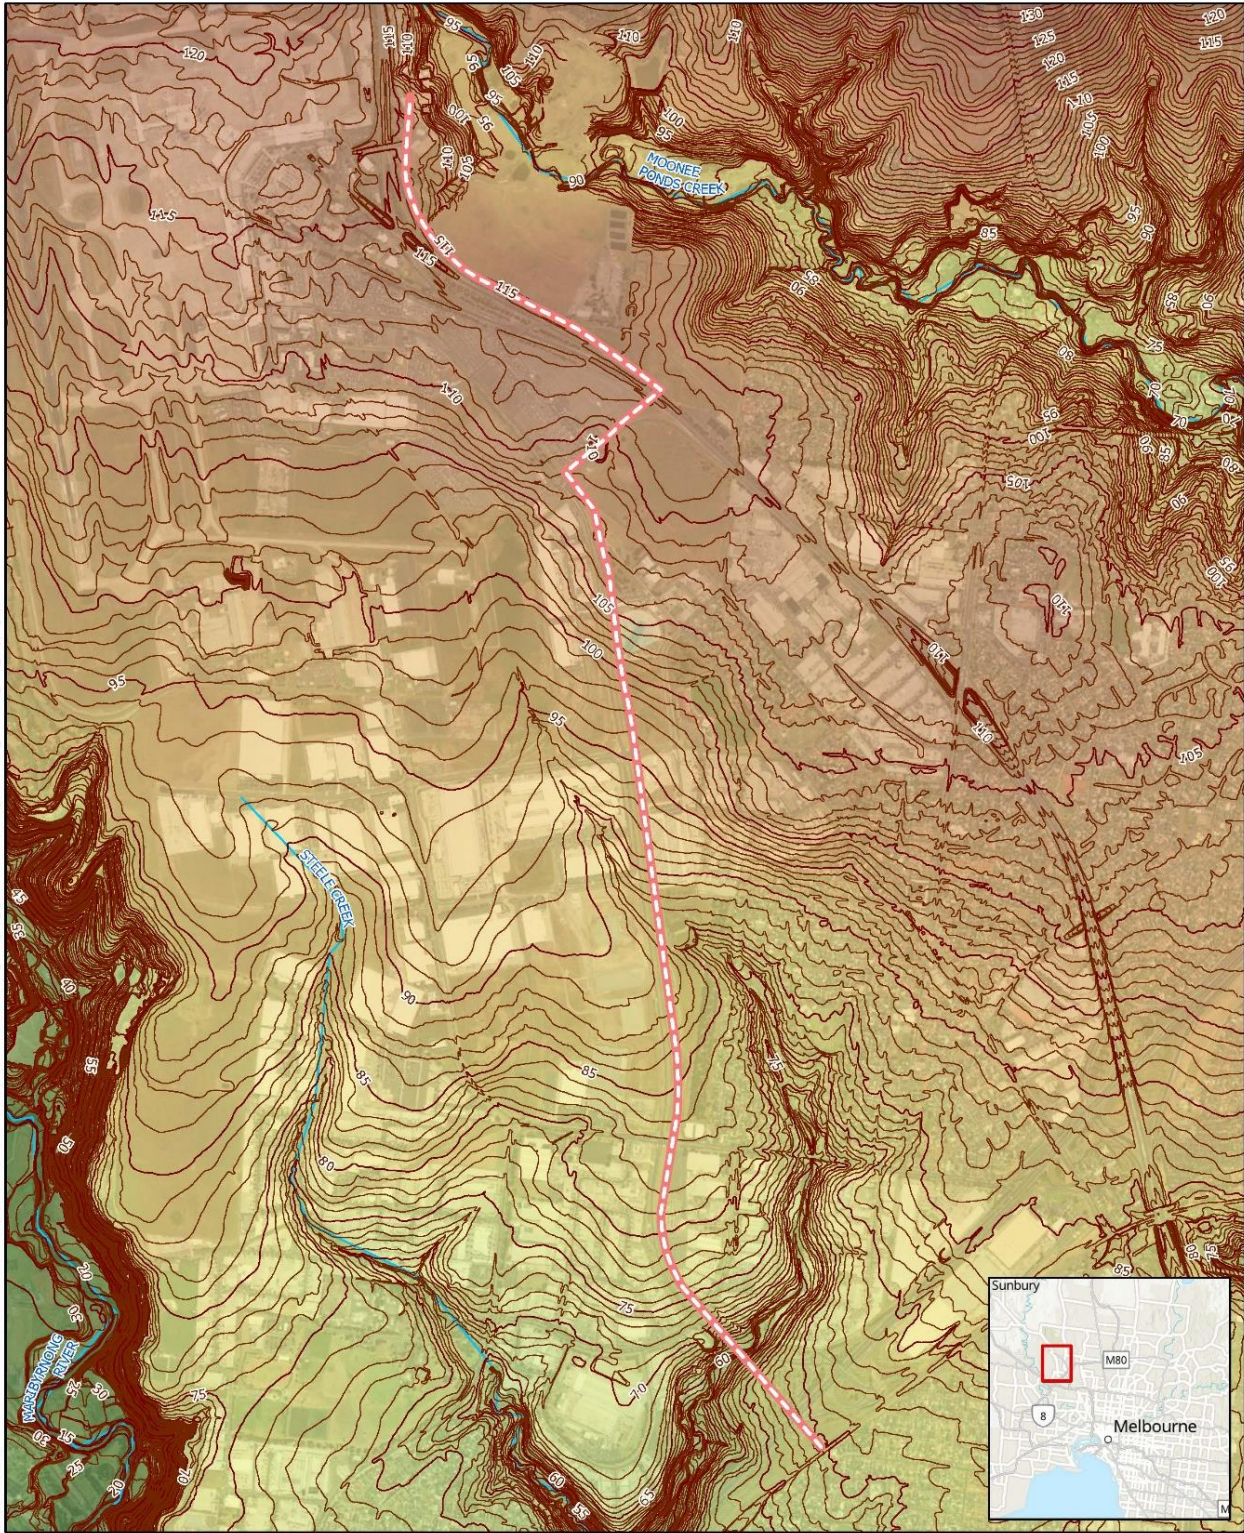
The general overland topography shows that the pipeline cuts across contours decreasing from 115 mAHD in the northern section to 60 mAHD in the southern section at the Steele Creek North crossing (**Figure 4-1**). An inferred north-south overland drainage pathway is indicated. Stormwater drainage generally follows the proposed alignment, with extensive networks around Mercer Drive between Tullamarine Freeway and Airport Drive, and this continues to follow Airport Drive until the Sharps Road intersection.

- Legend**
- - - MJP Pipeline
 - Contour
 - Watercourse

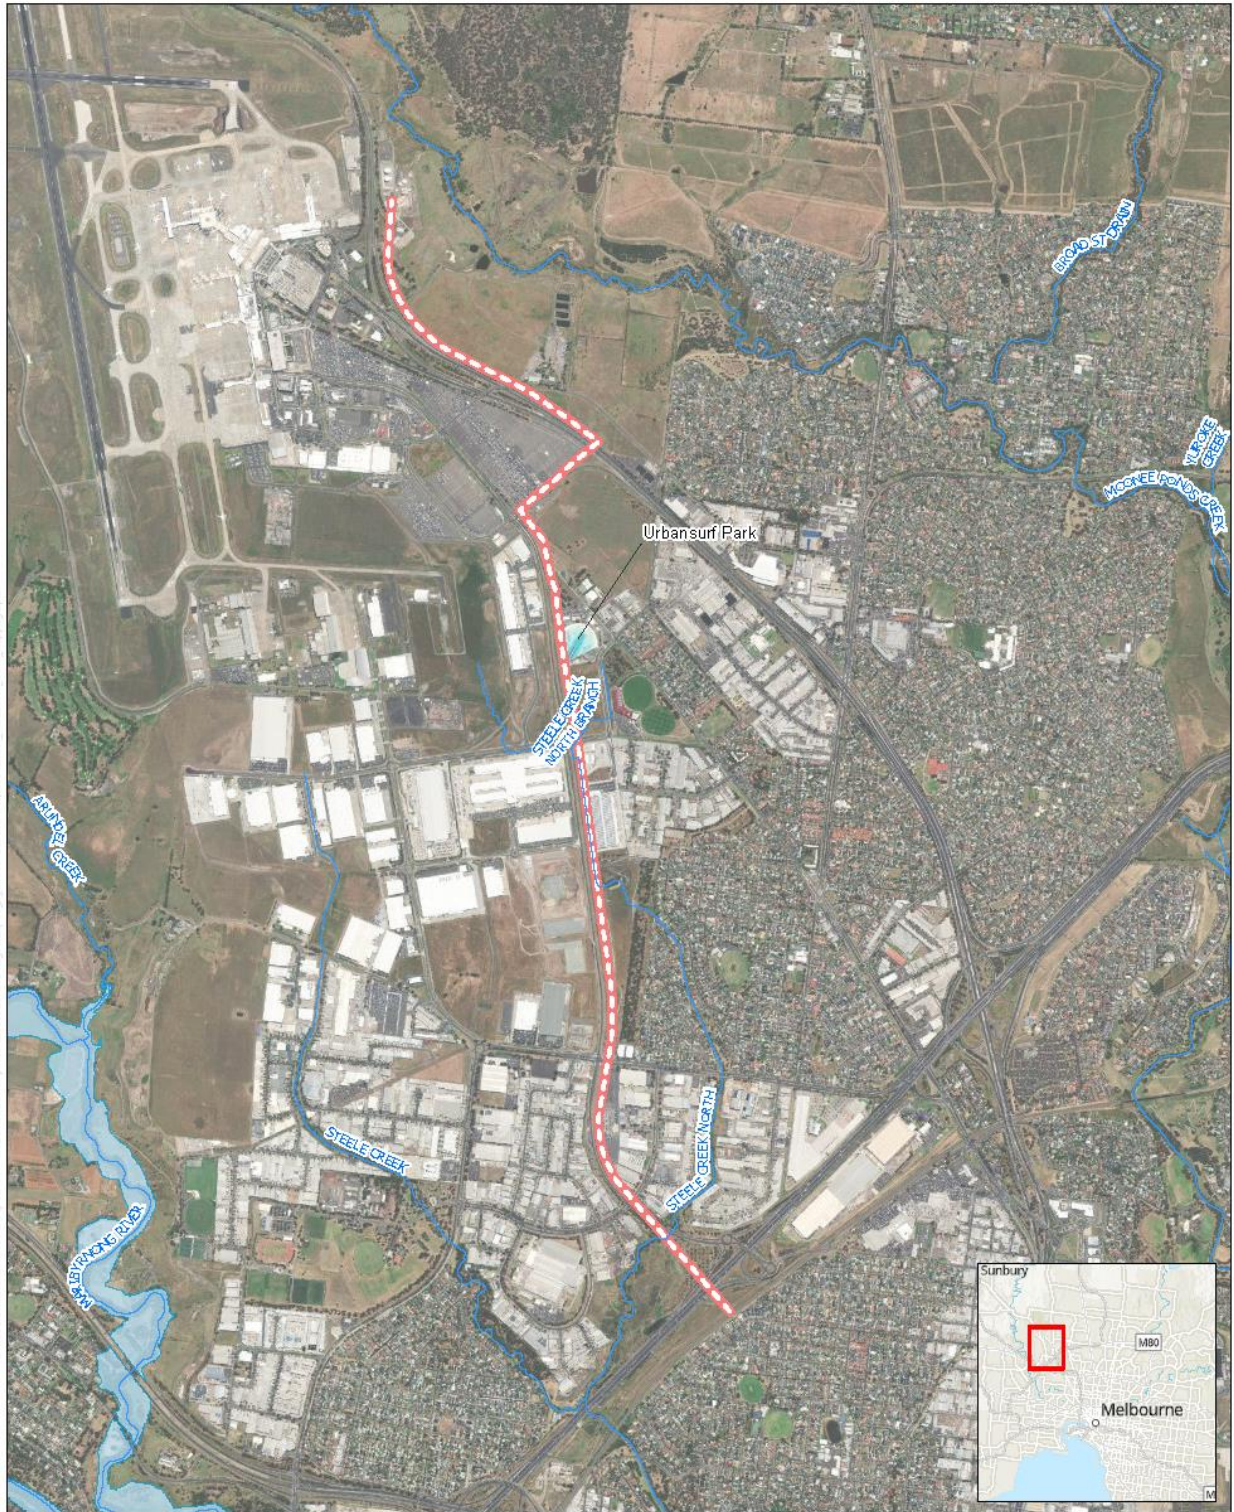
Water level changes in watercourses within the Study Area are expected to rise and fall quickly. Modelled 1-in-100 year riverine flood extents provided by DELWP (current as of 5 February 2018) were reviewed for the pipeline corridor and in a 1 km radius buffer around the project (**Figure 4-3**). Flood flows are constrained within the bankfull channel for Moonee Ponds Creek, Steele Creek and Steele Creek North with no overtopping onto adjacent land indicated in the mapping. The only other potential flood feature identified on the mapping was the ‘Urbsurf’ Surf Park located at 309 Melrose Drive, Tullamarine (**Figure 4-3**). No online searches could confirm if 1-in-100 year flood events would be contained within the footprint of the property (**Section 6.2**).

- - - MJP Pipeline
- Watercourse
- 1 in 100 years Flood Extent

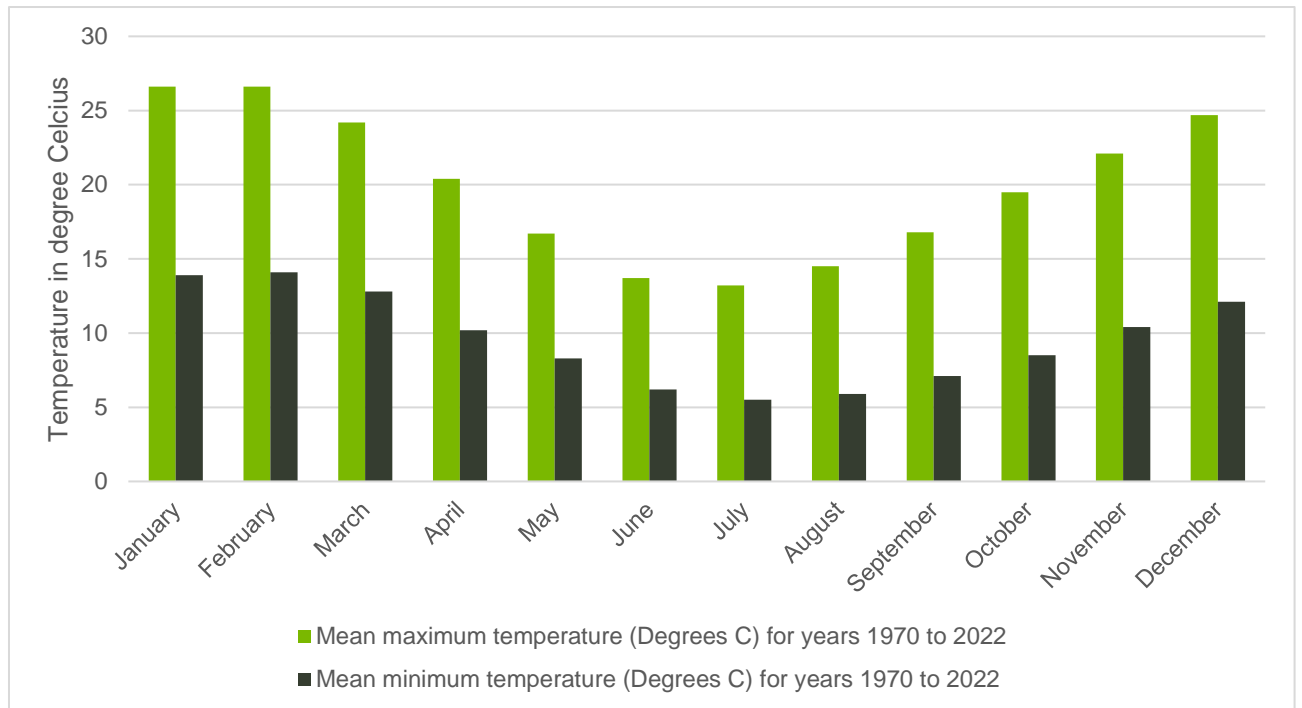
Temperature at Melbourne Airport has been increasing yearly, however seasonal trends remain similar. The warm season lasts three months, from early December to mid-March (**Figure A-1**). The mean maximum temperature is 26.6°C for the summer months. From mid-May through to early September, the temperature is much lower. The coldest month recorded is July, with the lowest temperature of 5.7°C.

Figure A-1 Monthly average maximum and minimum temperature from 1970 to 2022 (all years)

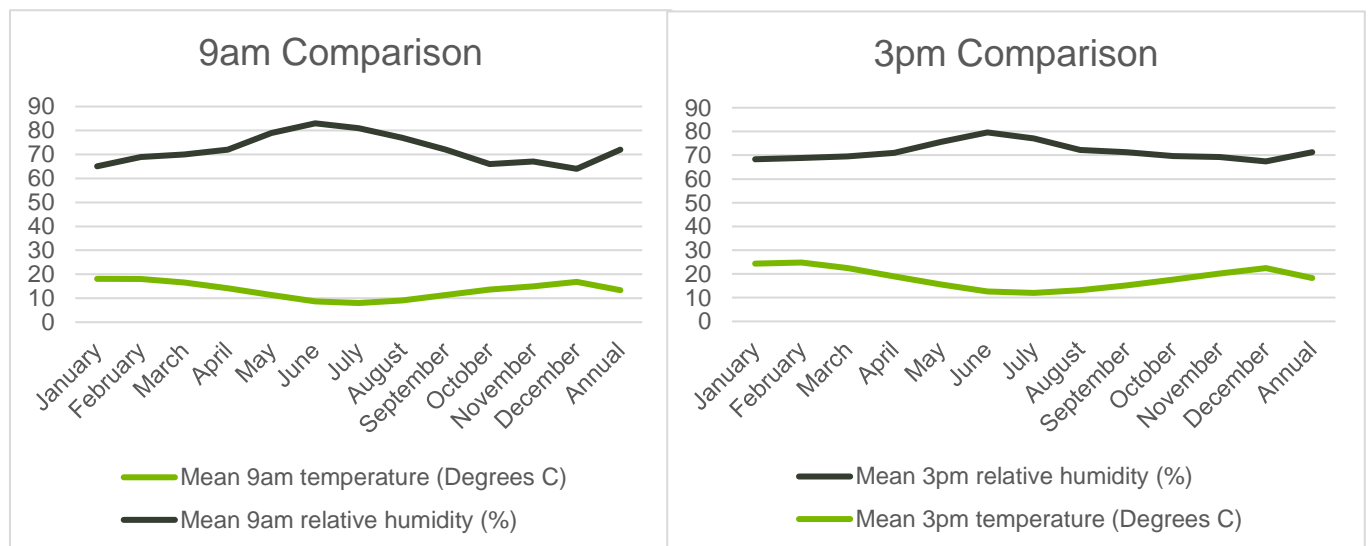
Figure A-3 Melbourne Airport 9am and 3pm temperature and relative humidity comparison

Relative humidity is highest in the coldest months (May, June, July and August) (**Figure A-3**). However, the data for relative humidity ceased in 2010, therefore it is difficult to apply these same trends and statistics to current data sets.

Temperature and humidity have been measured between 1970 to 2010. No data after 2010 has been reported on the BoM website. The 9am comparison shows a greater difference between humidity and temperature than the 3pm comparison (**Table A-1**). This correlates with current climate models of afternoon latent heat. as temperature decreases, relative humidity increases (Figure).

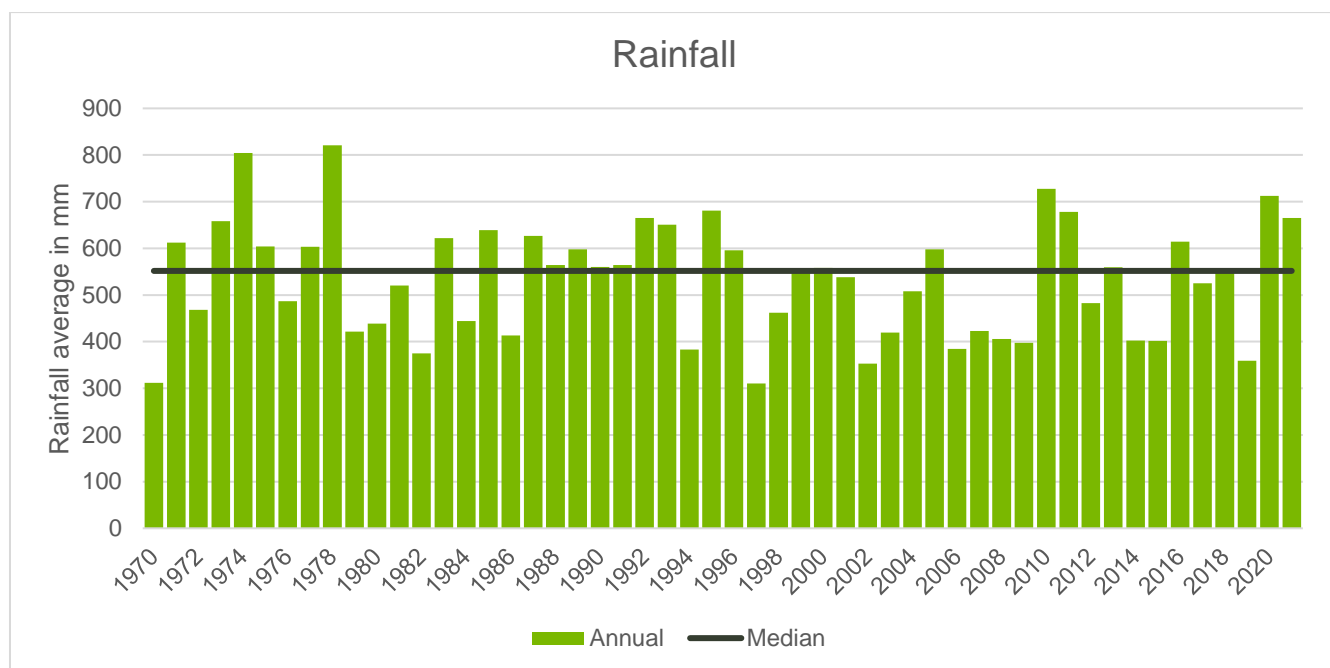
- Annual long term 50 year median rainfall of 554.6 mm / annum (**Figure A-5**).
- Mean Annual Evaporation of 500 mm / annum.
- Wetter than average years recorded rainfall in excess of 820.8 mm (**Figure A-5**).
- Drier than average years recorded rainfall less than 310.2 mm (**Figure A-5**).
- Higher rainfall during the spring and early summer months (August–December) compared to late summer – late autumn (January – July).
- Relatively warm and dry years on record for Melbourne Airport in the previous 15 years included 2002, 2005, 2006, 2009 and 2019 (Bureau of Meteorology, 2021). The high temperatures experienced were likely due to the influence of the El Niño.

Figure A-5 Average annual measured rainfall– Melbourne Airport (1970 - 2021)

The above trends have implications for hydrological behaviour, with a net surplus of rainfall to support stormwater runoff to surface water bodies and infiltration / recharge to the groundwater system on an annual basis.

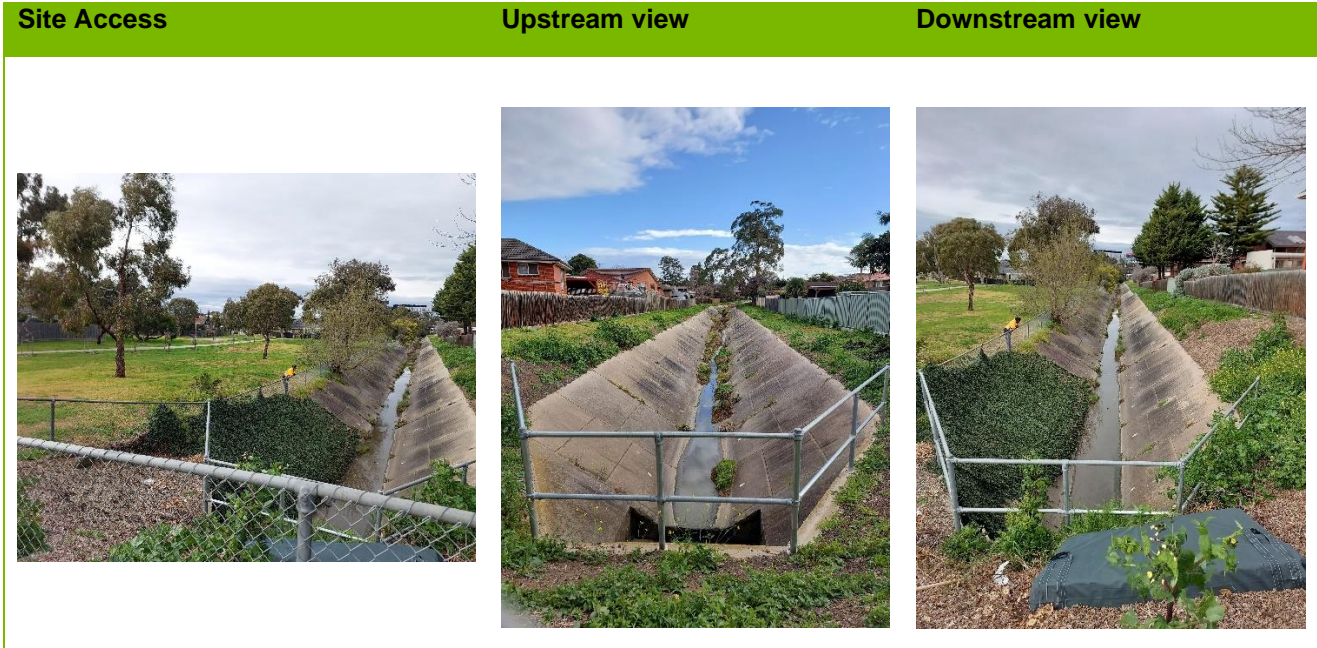
Location 2 – Steele Creek North upstream

- Residential area
- Maintained vegetation, mowed grasses, limited weeds.
- Fencing surrounding drain – no access
- Low flow water in drain
- Water – no odour, slightly clear brown colour, no signs of wildlife, no sheen, moving

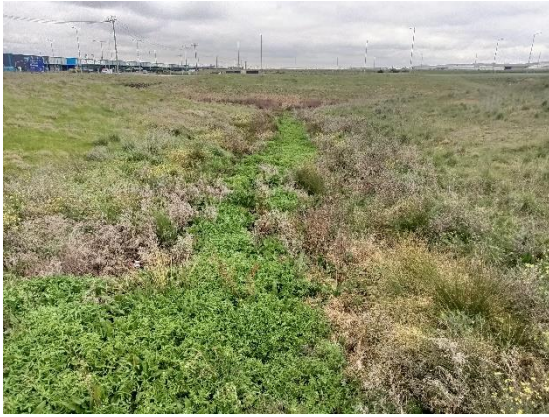
South-Arm Channel looking west towards Airport Drive

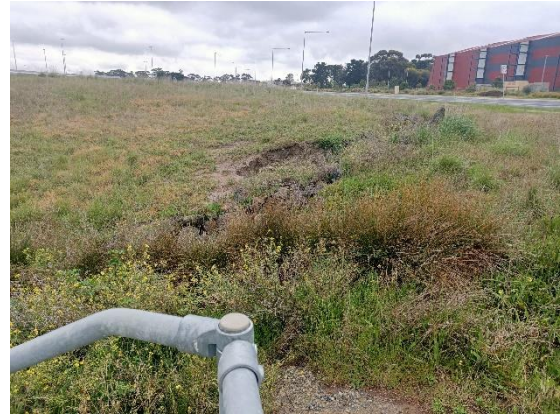
Erosion of axillary stormwater channel discharging into South-Arm Channel at Watson Drive

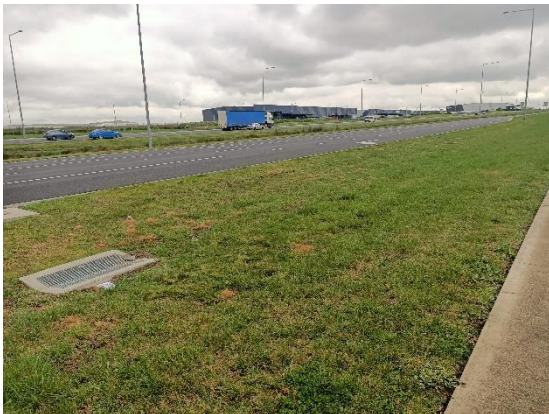
Stormwater grated inlet draining grassed roadside swale discharging into catch pit on Airport Drive

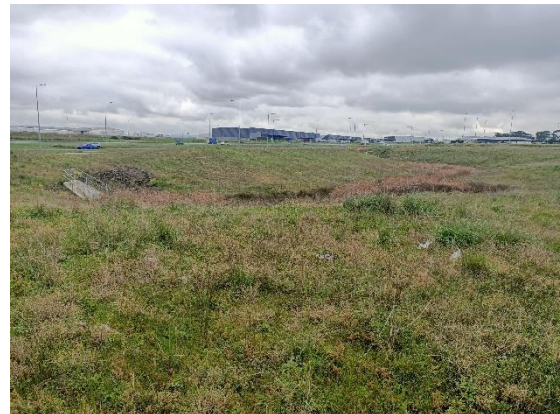
North-Arm Channel with Culvert (left hand side) under Airport Drive

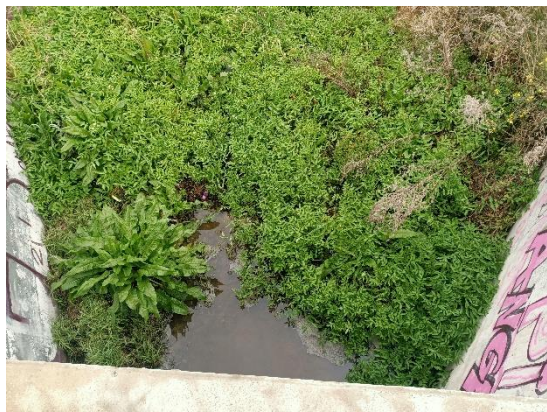
- Dry channels at time of observations except around culvert where enlarged / deepened pools of stagnant water are present
- Visible bubbles / film on surface of water around culverts, no odour, dark brown murky colour

Close up of South Arm culvert showing extensive non-native macrophyte growth and stagnant water with surface film

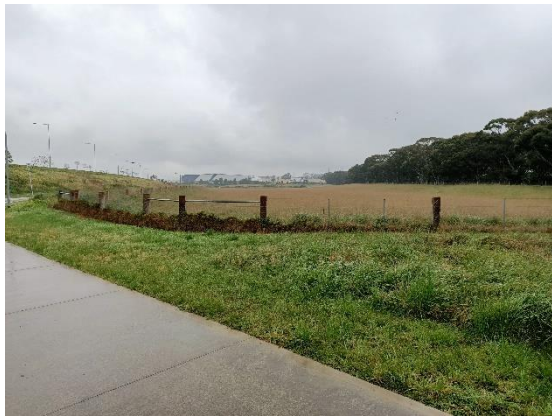
Far south extent of retention basin looking northwards

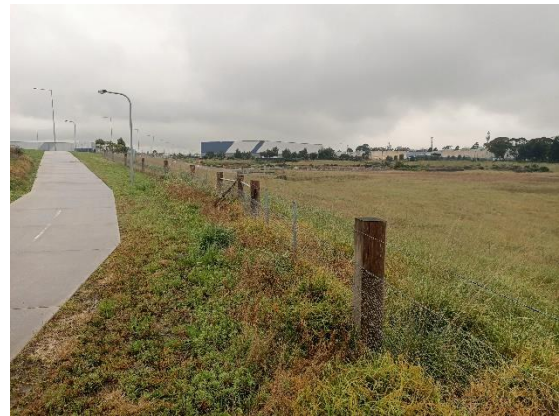
North extent of retention basin looking northwards towards raingarden
