Viva Energy Clyde Western Area Remediation Project - Stage 1

2 Durham Street, Rosehill, NSW Site Audit Report

June 2020

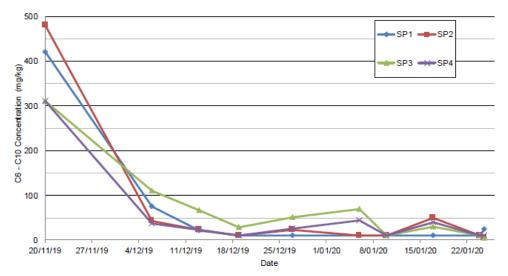
Figure 1 (Figure 4.4. from ERM, 2020f) graphs the rate of C6-C10 TRH fraction reduction throughout the course of the remediation trial.

Figure 1 C6-C10 TRH concentrations measured during biopiling remediation trials over time (AEC-9 material)

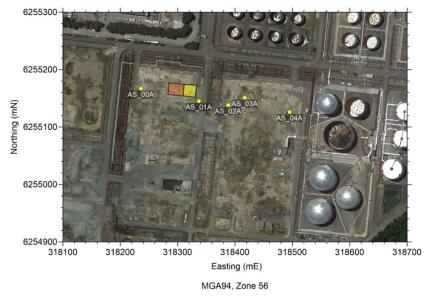
Ambient monitoring was carried out at five locations (AS_00A, AS_01A, AS_02S, AS_03A and AS_04A) including an upwind sample (AS_00A) to provide information on potential interference from upwind sources. Four downwind samples were collected (AS_01A - AS_04A) which were located at increasing distances from the excavation activities. **Figure 2** (Figure 4.5 from ERM, 2020f) shows these monitoring locations relative to the excavation area.

Figure 2 Remediation trial excavation area showing air quality sampling locations, excavation and stockpiling areas

ERM (2020f) reported that ambient VOC concentrations were observed to decrease significantly with distance from the remediation trial excavation area, with all compounds below the LOR at a distance of 165 metres from the excavation area.

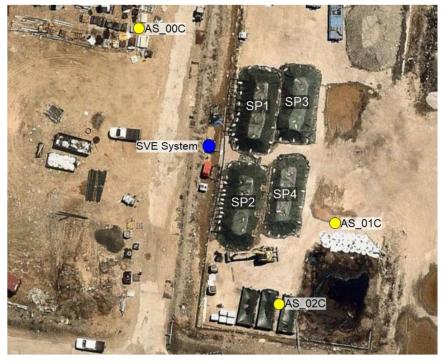
Figure 3 Location of biopiles (SP1 to SP4) and air sampling locations

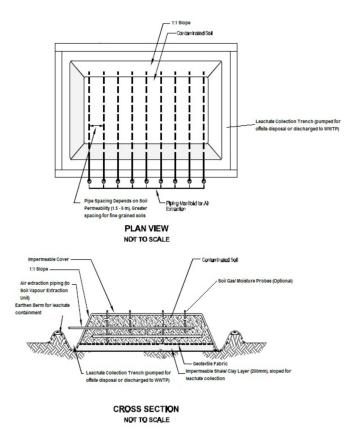
Figure 4 Biopile Construction Schematic – Adapted from USEPA (2017)

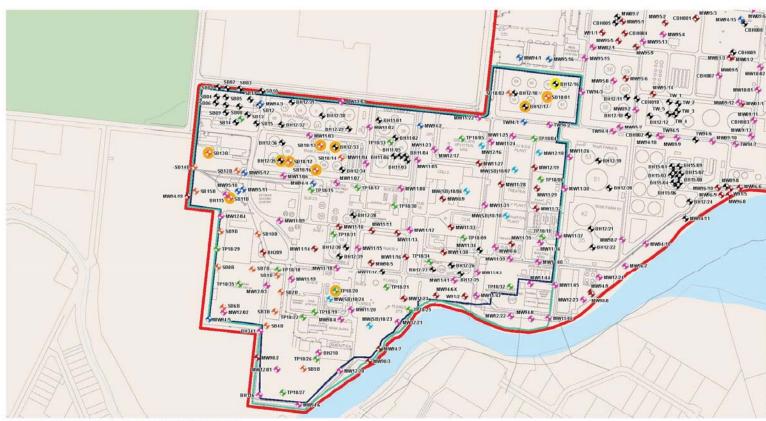
FIGURE 8-1: HYDROCARBON EXCEEDANCES IN SOIL 0-1M BGL

Figure 8-1 Hydrocarbon Impacts in Soil: 0-1 metre below ground level

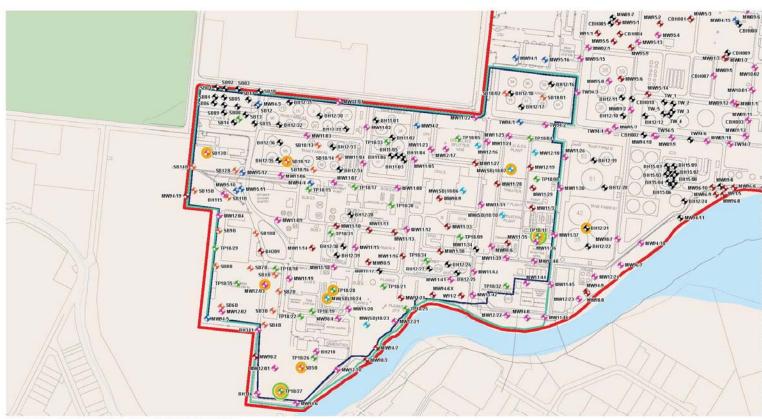
FIGURE 8-2: HYDROCARBON EXCEEDANCES IN SOIL 1-2M BGL

Figure 8-2 Hydrocarbon Impacts in Soil: 1-2 metres below ground level

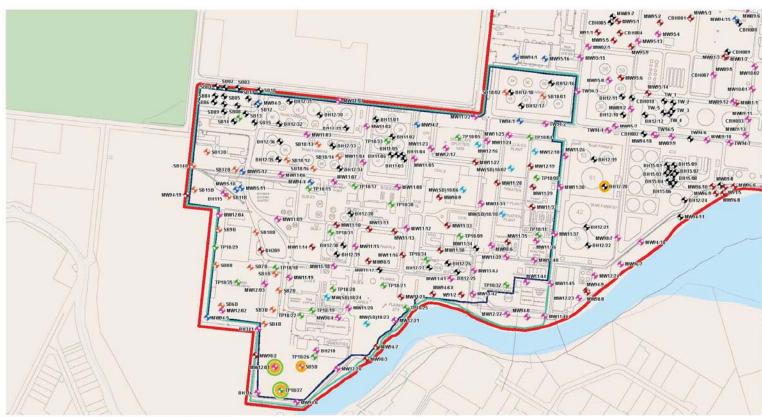
FIGURE 8-3: HYDROCARBON EXCEEDANCES IN SOIL 2-4M BGL

Figure 8-3 Hydrocarbon Impacts in Soil: 2-4 metres below ground level

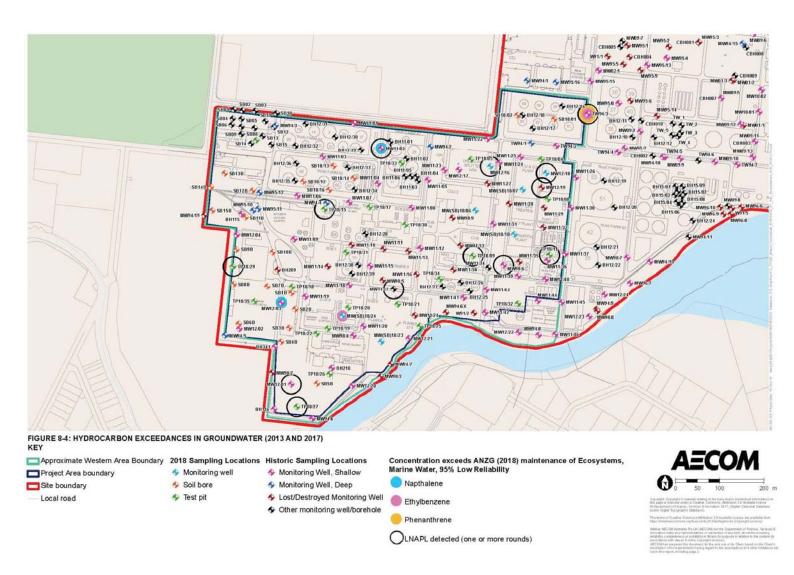
Figure 8-4 Hydrocarbon Exceedances in Groundwater (2013 and 2017)

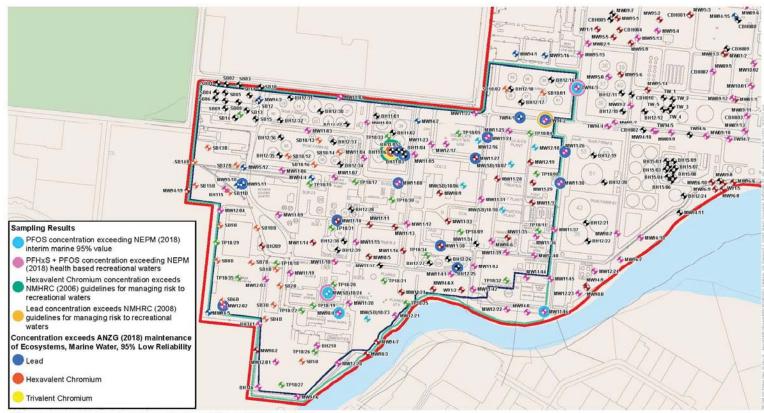
FIGURE 8-5: OTHER COPC EXCEEDANCES IN GROUNDWATER (2013 AND 2017)

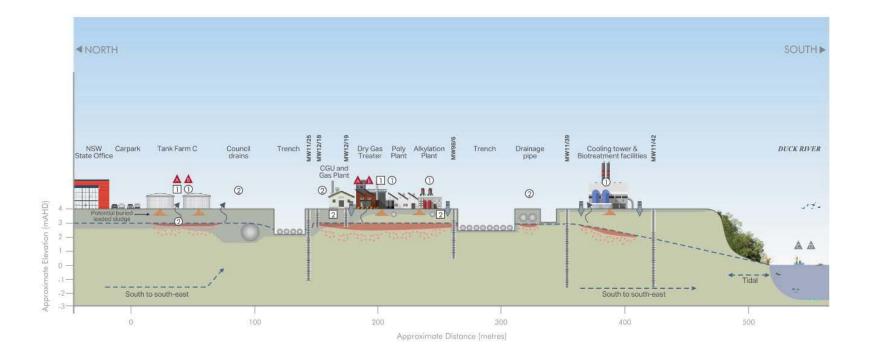
| LEGEND | POTENTIAL SOURCES | POTENTIAL PATHWAYS |
|---|---|--|
| Fill material Alluvium/stiff clay Soil impacts LNAPL Dissolved phose impact Inferred groundwater elevation Tanks/pipeworks Oxygen ingress Vapour migration Camplete exposure pathway Incomplete exposure pathway Potential pathway | Historic leaks from tanks, pipes (Primary Sources) LNAPL within soils or within drains/drain surrounds (Secondary Source) POTENTIAL RECEPTORS Onsite workers Onsite intrusive maintenance workers Duck River ecosystem Duck River recreational users | Indoor inhalation of vapours migrating from shallow soil/groundwater through service lines or the floor slab Outdoor inhalation of vapours from shallow soil/groundwater Incidental ingestion and dermal contact with surface soil, shallow soil with surface and shallow soils Groundwater flow in trench and/ar pipe backfill Potential groundwater flow in trench |

Figure 8-6 Conceptual Site Model

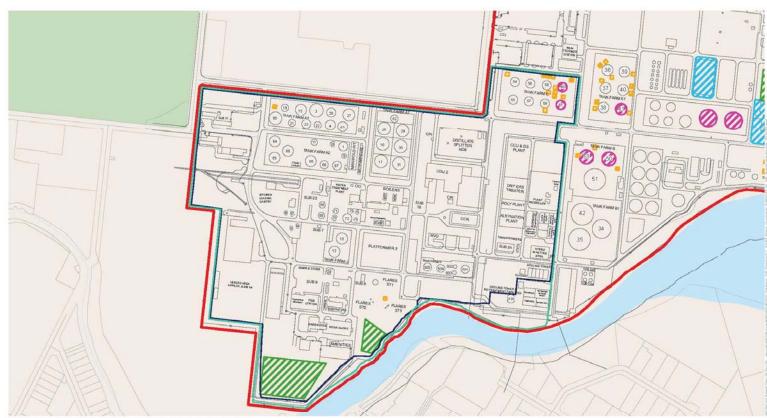
FIGURE 9-2 - HISTORIC LOCATION OF BURIED LEADED SLUDGE

Figure 9-2 Historic location of buried leaded sludge

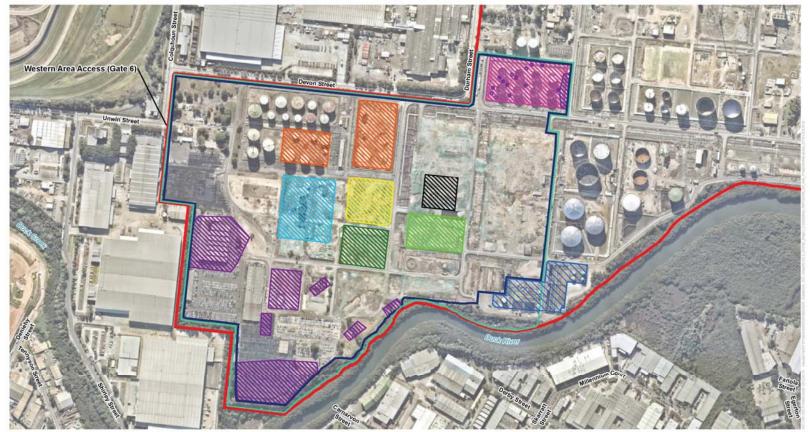
FIGURE 15-1 - WESTERN AREA PROPOSED REMEDIATION LAYOUT
